# **INDOOR AIR QUALITY REASSESSMENT**

**Mass Commission Against Discrimination  
One Ashburton Place, 6th floor  
Boston, MA**

Prepared by:  
Massachusetts Department of Public Health  
Bureau of Environmental Health  
Indoor Air Quality Program  
June 2018

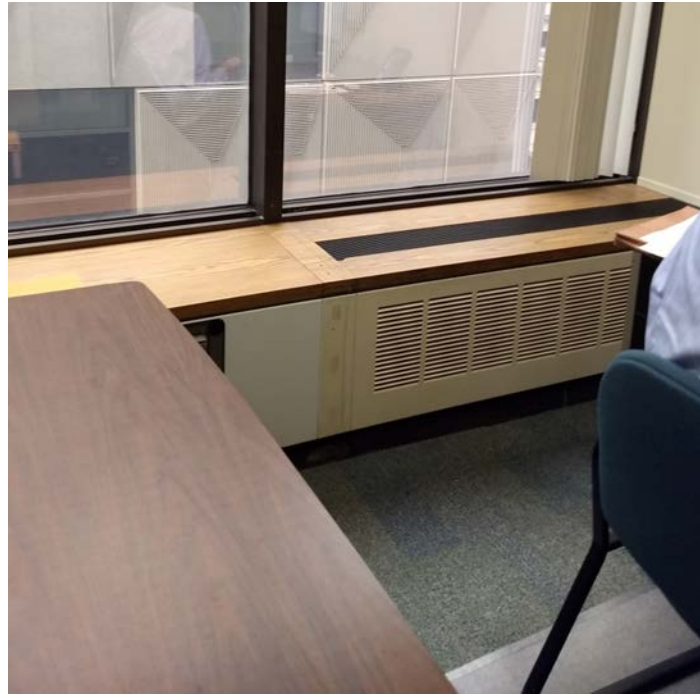
**Picture 1**

Fresh air is supplied by induction units located along the outer edges of the building (Picture 1) and supply vents located in the ceiling. Return air is drawn through vents around light fixtures using ducted returns. Some induction units had items on top of them, which can obstruct the flow of fresh air. In addition, some of the items on/near the vents of the induction units can be a source of dusts, odors and, in the case of plants, pollen, and other potential allergens. Induction unit vents should be kept free of items and kept clean.

**Induction unit for fresh air in offices**

3. Regularly clean induction unit fins and condensation pans (if any) to reduce accumulated debris.
4. Remove items from the top and front of induction units to allow for air flow.

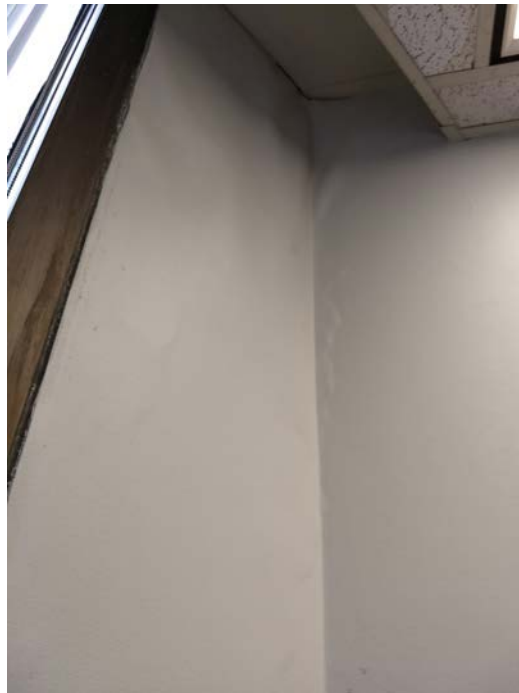
**Picture 2**

The main source of concern for this area is water damage. Due to the age and condition of the building, water leaks around/near the windows have occurred in this building during wind-driven rain events. Water-damaged ceiling tiles and wall materials were observed near windows in the offices examined (Pictures 2 through 4). As shown in Picture 3, deterioration of wall plaster was significant in some of the rooms. Covering materials were added to the walls in some areas to reduce generation of dust from plaster and to make the damage less visible (Picture 5). Rust stains are also visible on some window frame materials. Note that plaster, and the metal and glass of the window frame, are not conducive to mold growth because they lack available carbon/organic material that mold needs to live. No signs of mold growth (e.g., odors, dark staining) were noted on any materials examined, including ceiling tiles. Water-damaged ceiling tiles should be replaced when discovered.

**Water-damaged wall near window**

5. Replace water-damaged ceiling tiles. Avoid storing porous items in areas where leaks occur. Ensure building management is aware of significant leaks or increases in leaking.

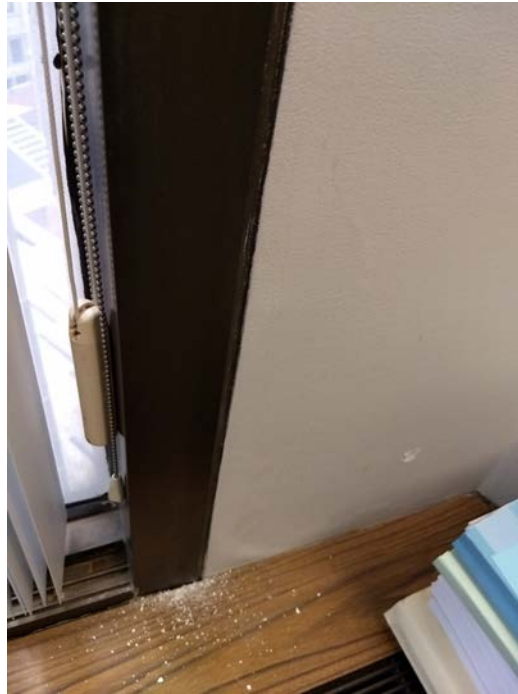
**Picture 3**

**Plaster flaking off wall shown in Picture 2, from underneath top layer on wall**

6. Ensure plaster and coverings over plaster are in good condition to prevent dust generation.
7. Keep plants in good condition, avoid overwatering, and remove from the airstream of heating and ventilation equipment.

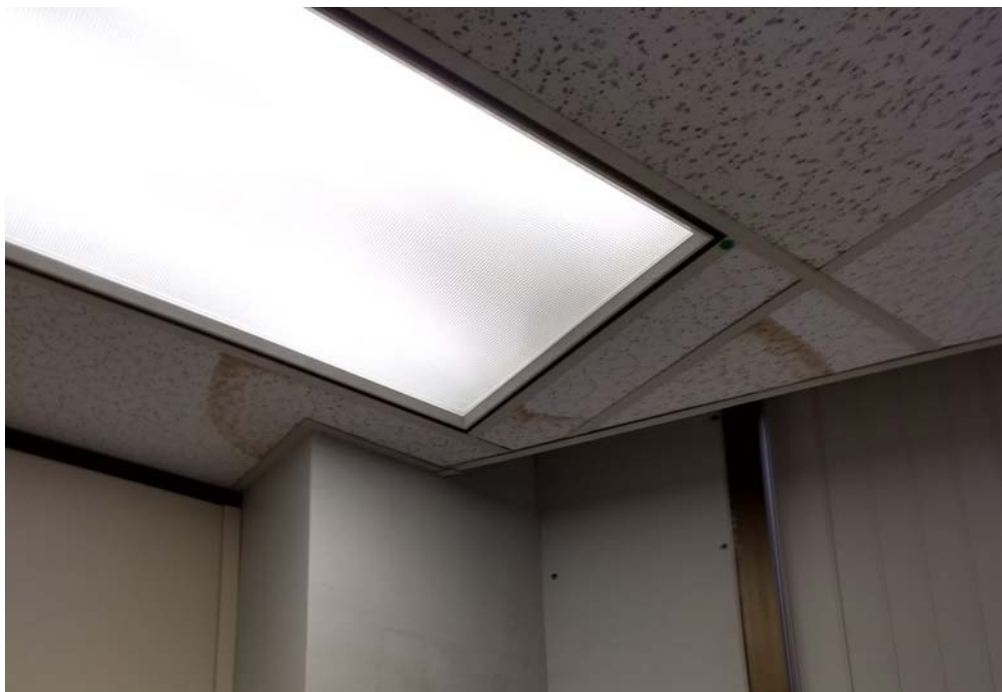
**Picture 4**

**Water-damaged ceiling tile**

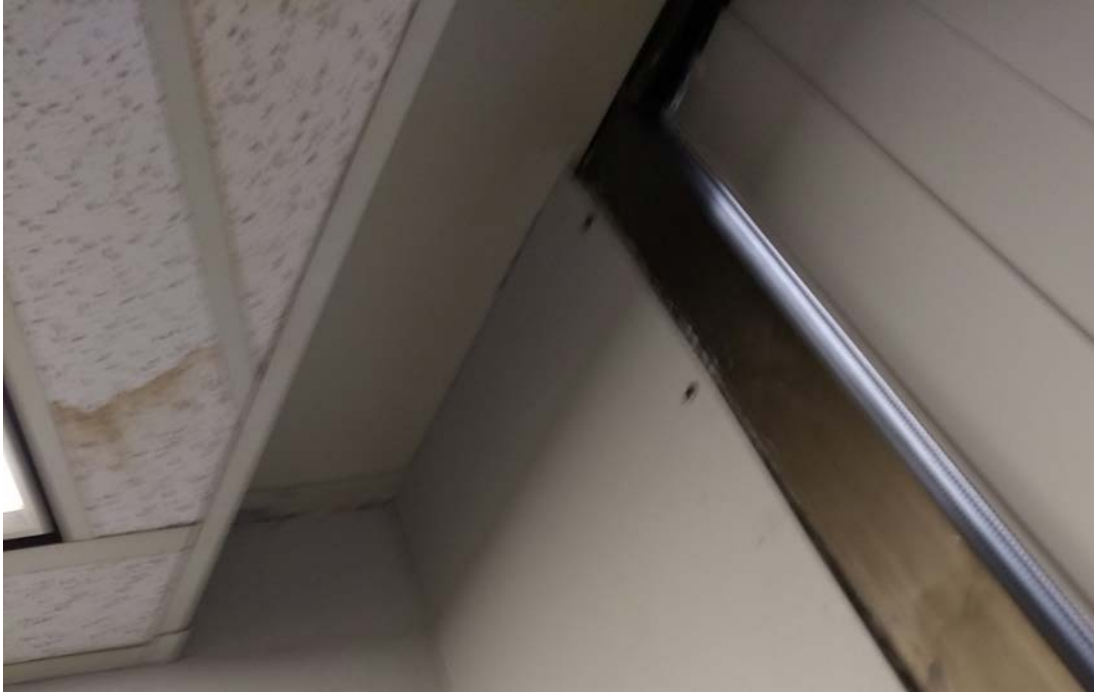
**Picture 5**

**Laminate material bolted to wall to cover plaster**

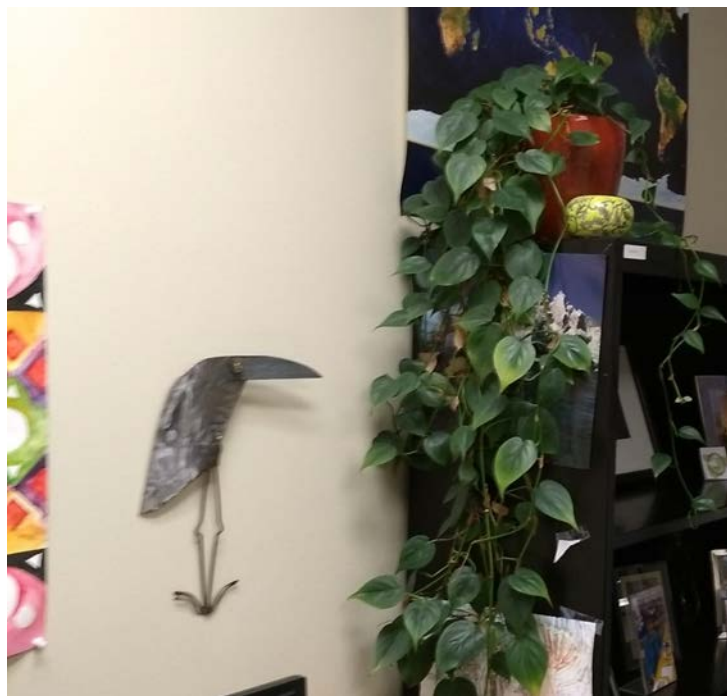
**Picture 6**

Plants were noted in a few areas (Table 1; Pictures 4 and 5). Plants can be a source of pollen and mold, which can be respiratory irritants to some individuals. Plants should be properly maintained and equipped with drip pans and should be located away from induction units to prevent the aerosolization of dirt, pollen, and mold.

**Plant in an office**

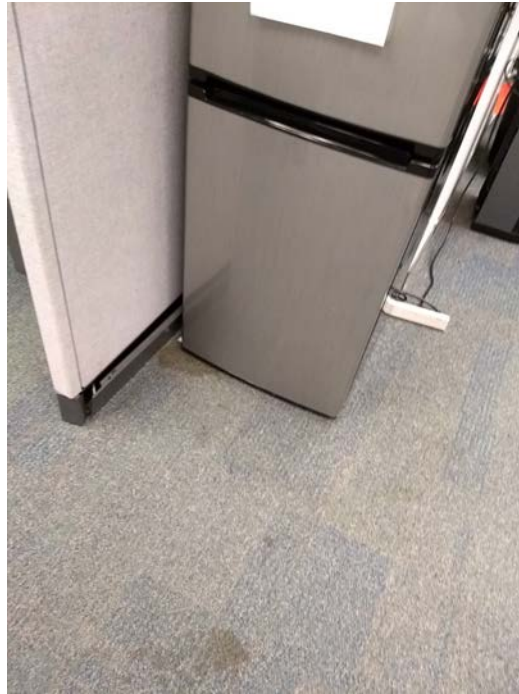
**Picture 7**

A refrigerator and water dispenser were located on carpet (Picture 7). As shown in Picture 7, there are stains on the carpet likely from spills of items from the refrigerator. Refrigerators and water dispensing equipment should be located in a non-carpeted area or on a waterproof mat to prevent damage to carpet and subsequent odors.

**Small refrigerator with stained carpeting**

8. Consider the use of waterproof mats underneath refrigerators and water dispensers to protect carpet from leaks and spills.
9. For buildings in New England, periods of low relative humidity during the winter are often unavoidable. Therefore, scrupulous cleaning practices should be adopted to minimize common indoor air contaminants whose irritant effects can be enhanced when the relative humidity is low. To control for dusts, a high efficiency particulate arrestance (HEPA) filter equipped vacuum cleaner in conjunction with wet wiping of all surfaces is recommended. Avoid the use of feather dusters. Drinking water during the day can help ease some symptoms associated with a dry environment (throat and sinus irritations).
